Manhole Inspection Summary

Manhole # S25YY1002MH

Insp Date: **5/10/07 11:30 AM**

Location Address: **5400 ROLAND AVE**

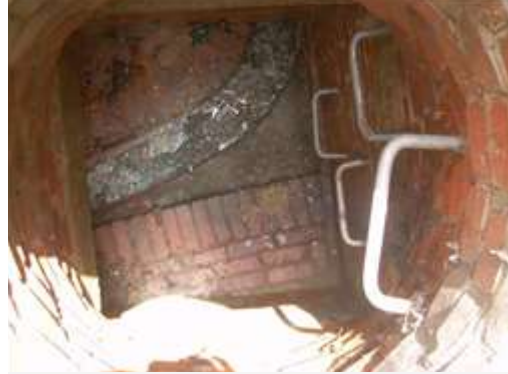
Top View

Channel and Bench debris.

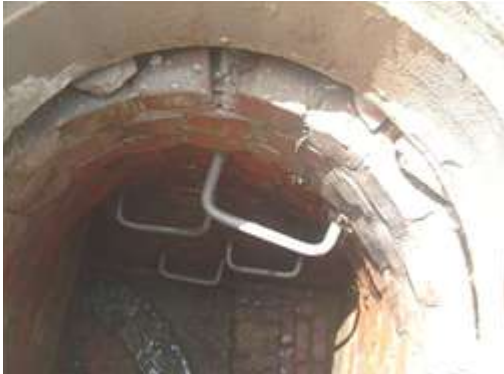
Defect

Frame Offset: **1** (in.) Condition: ☐ Sound ☐ Cracked ☒ **Leaks**

Condition: ☐ Sound ☐ Cracked ☐ Root Intrusion ☒ **Loose Brick** ☒ **Deteriorated**

Infiltration: ☐ None ☒ **Joint** ☐ Cracks ☐ Mortar ☐ Roots ☒ **Wall**

Infiltration: ☐ None ☐ Joint ☐ Cracks ☒ **Mortar** ☐ Roots ☒ **Wall**

Frame leaks. Frame offset. Adjustment deterioration, loose brick and infiltration. Corbel and Barrel infiltration.

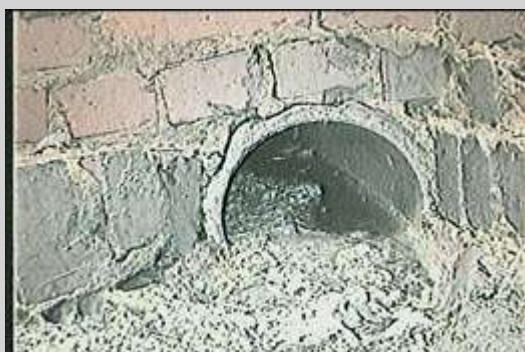
Pipe Out @ 12 O'Clock

6 in. Circular Gravity Sewer

Deposits: ☐ None ☒ **Mud** ☐ Sludge ☒ **Debris** ☒ **Grease**

Silt Depth: **2** (in.)

Deposits Extent: **Medium**

Pipe Seal Cond: **Cracked**

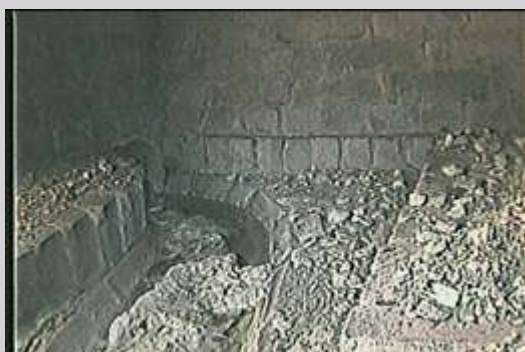
Pipe In @ 6 O'Clock

Channel deterioration and debris.

Deposits: ☐ None ☐ Mud ☐ Sludge ☒ **Debris** ☐ Grease

Deposits Extent: **Light**
